## SKID ROOF RESTORATION

REMOVAL AND REPLACEMENT OF A GALBESTOS ROOF.

Talisman

Fulmar A, North Sea

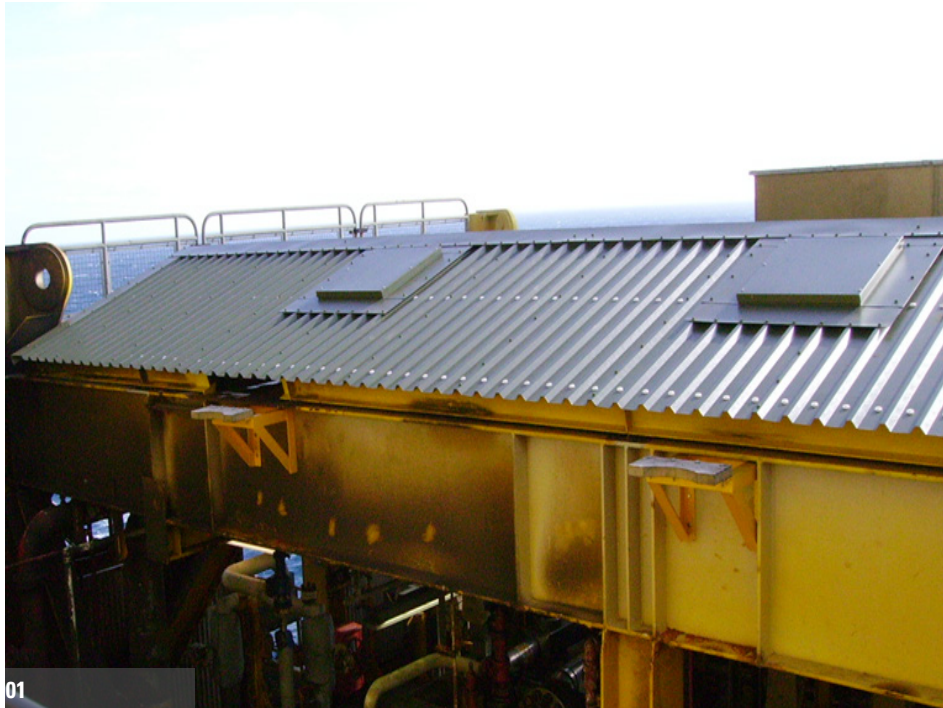
01 - Bilfinger Salamis UK designed and installed a new roof on the Fulmar A platform

The new roof was then installed using a more suitable panelling material.

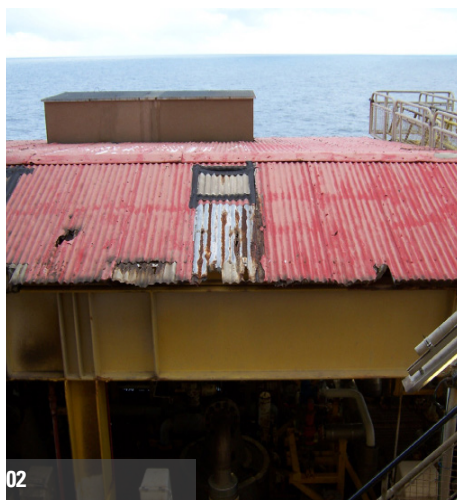
Sheeting material located on a module roof on Talisman's Fulmar A platform was identified as containing Chrysotile (white) asbestos - the material which is bonded to the outside of a corrugated metal sheet, described as "Galbestos" sheeting.

02 - The existing roof showing signs of deterioration

Due to deterioration, water ingress and material composition, Bilfinger Salamis UK were asked to remove and dispose of the existing sheeting, and design and install a new roof.

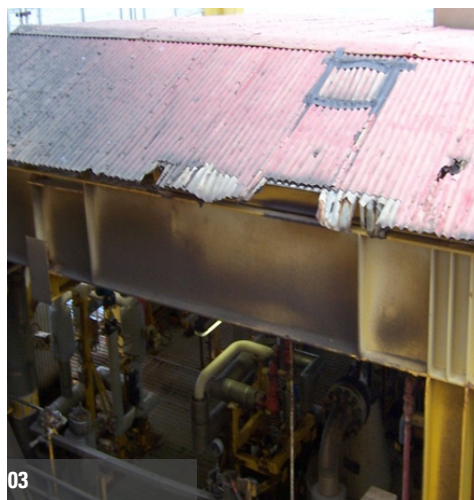
03 - The deterioration of the existing roof was allowing water ingress

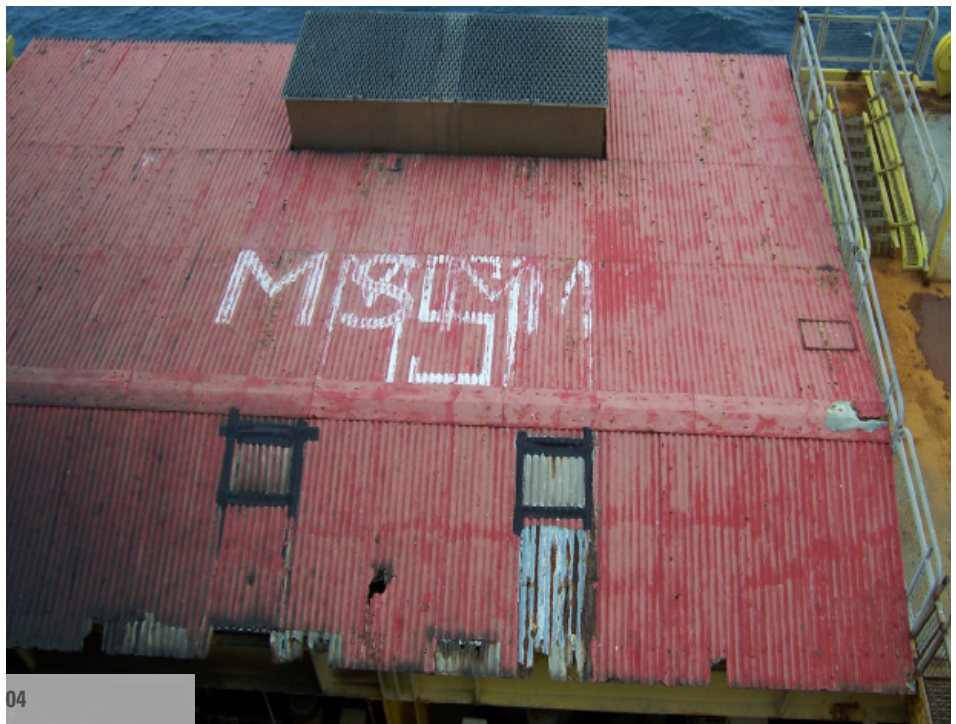
04 - Skid roof before

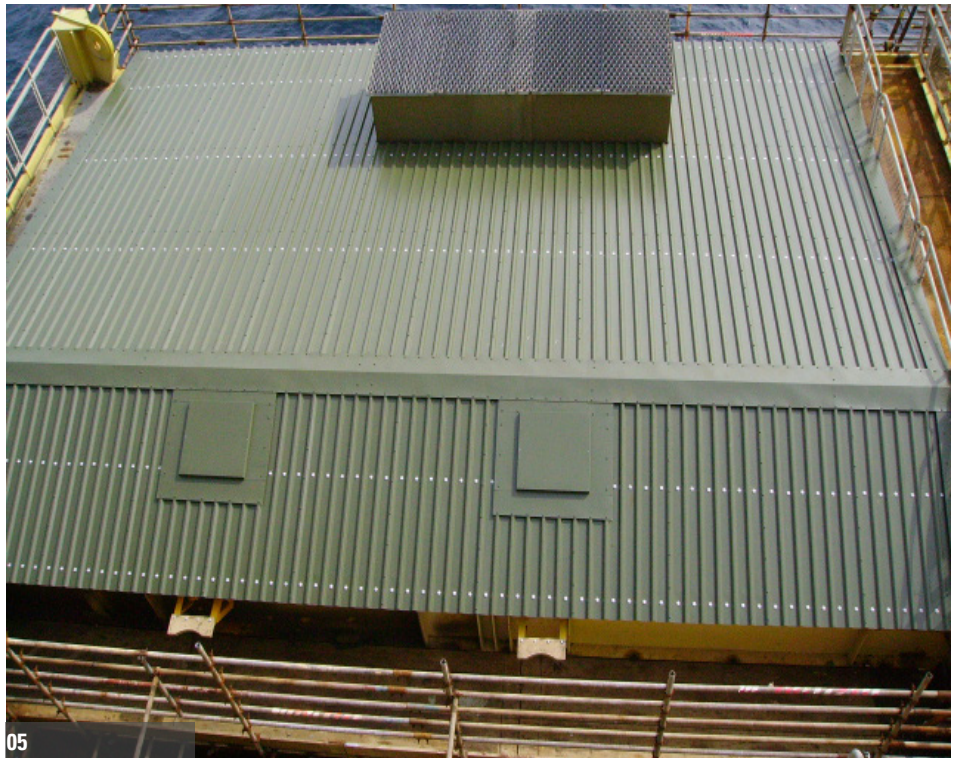
05 - Our designers integrated a number of new concepts to the design of the roof, including hatches for ease of access to the module

A number of new concepts were integrated into the end design - two new roof top hatches to provide access to molecular sieve vessels within the module, and two new bumper bars were added to the façade to prevent damage from a crane rope.

The new roof is made of a corrosion resistant material, which will inhibit water ingress, and require little maintenance. The roof also provides a safer habitat for workers, with all existing asbestos removed, and new hatches creating ease of access to the module.
